# <u>User Inspection Notice</u>

MSA V-EDGE® Web PFLs

August 2025
PLEASE READ NOW AND TAKE ACTION

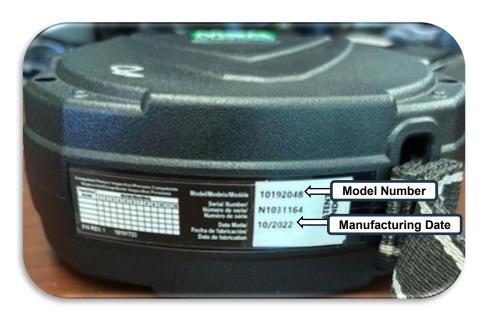
Figure 2: Product Identification

# 1) Confirm Model Number and Manufacturing Date – Refer to Figure 2

- i. Confirm that your model number is listed in the table in the appendix.
- ii. If your model number is not listed, no further action is needed.

- i. Confirm that your manufacturing date is between 05/2018 and 01/2025
- ii. If the date is outside of this range, no further action is needed.

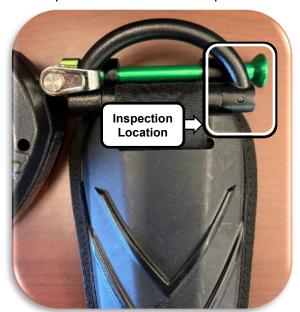
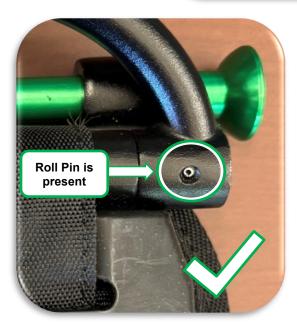
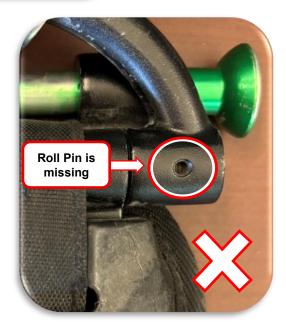
Figure 3: Roll Pin Inspection

MSA has received an isolated field report that a bolt that connects the PFL ring to the Energy Absorber of the V-EDGE Web PFL separated from the unit, resulting in the unit being non-functional. MSA has not received any reports of injuries associated with this condition. However, we request that you perform the inspection outlined in this notice prior to your next use and include it in your pre-use checks and examination procedures.

- Inspect the product Visually inspect the bolt that connects the PFL ring to the Energy Absorber of the V-EDGE PFL for the presence of the silver roll pin. (Figure 3)
  - a. Roll pin is present and flush Continue using product per manufacturer recommendations.
  - b. Roll pin is protruding or not present Remove the product from service and follow the procedure below for a replacement unit.

MSA is advising all customers to inspect for the presence of the silver roll pin during pre-use checks for MSA V-EDGE Web PFLs listed in this notice.

Inspect all units per the instructions in this notice prior to your next use. If any PFL does not pass this inspection, remove it from service and contact MSA.

If you are in possession of any MSA V-EDGE Web PFLs whose roll pin is not properly secured, we will replace them free of charge. In an effort to minimize any disruption, we pledge to take any replacement actions as expeditiously as possible.
